Snow Pit Profile  
**Hebgen Lake**  
**Henry Lake Mtns, MT**  
 Elevation (ft) **9000**  
 Aspect: **150**  
 Specifics: **Collapsing, localized. Cracking.**

Observer: **Doug Chabot**  
**Mon Feb 27 12:00:00 MST 2012**  
 Co-ord: **N W**  
 Slope: **24**  
 Wind loading: **no**

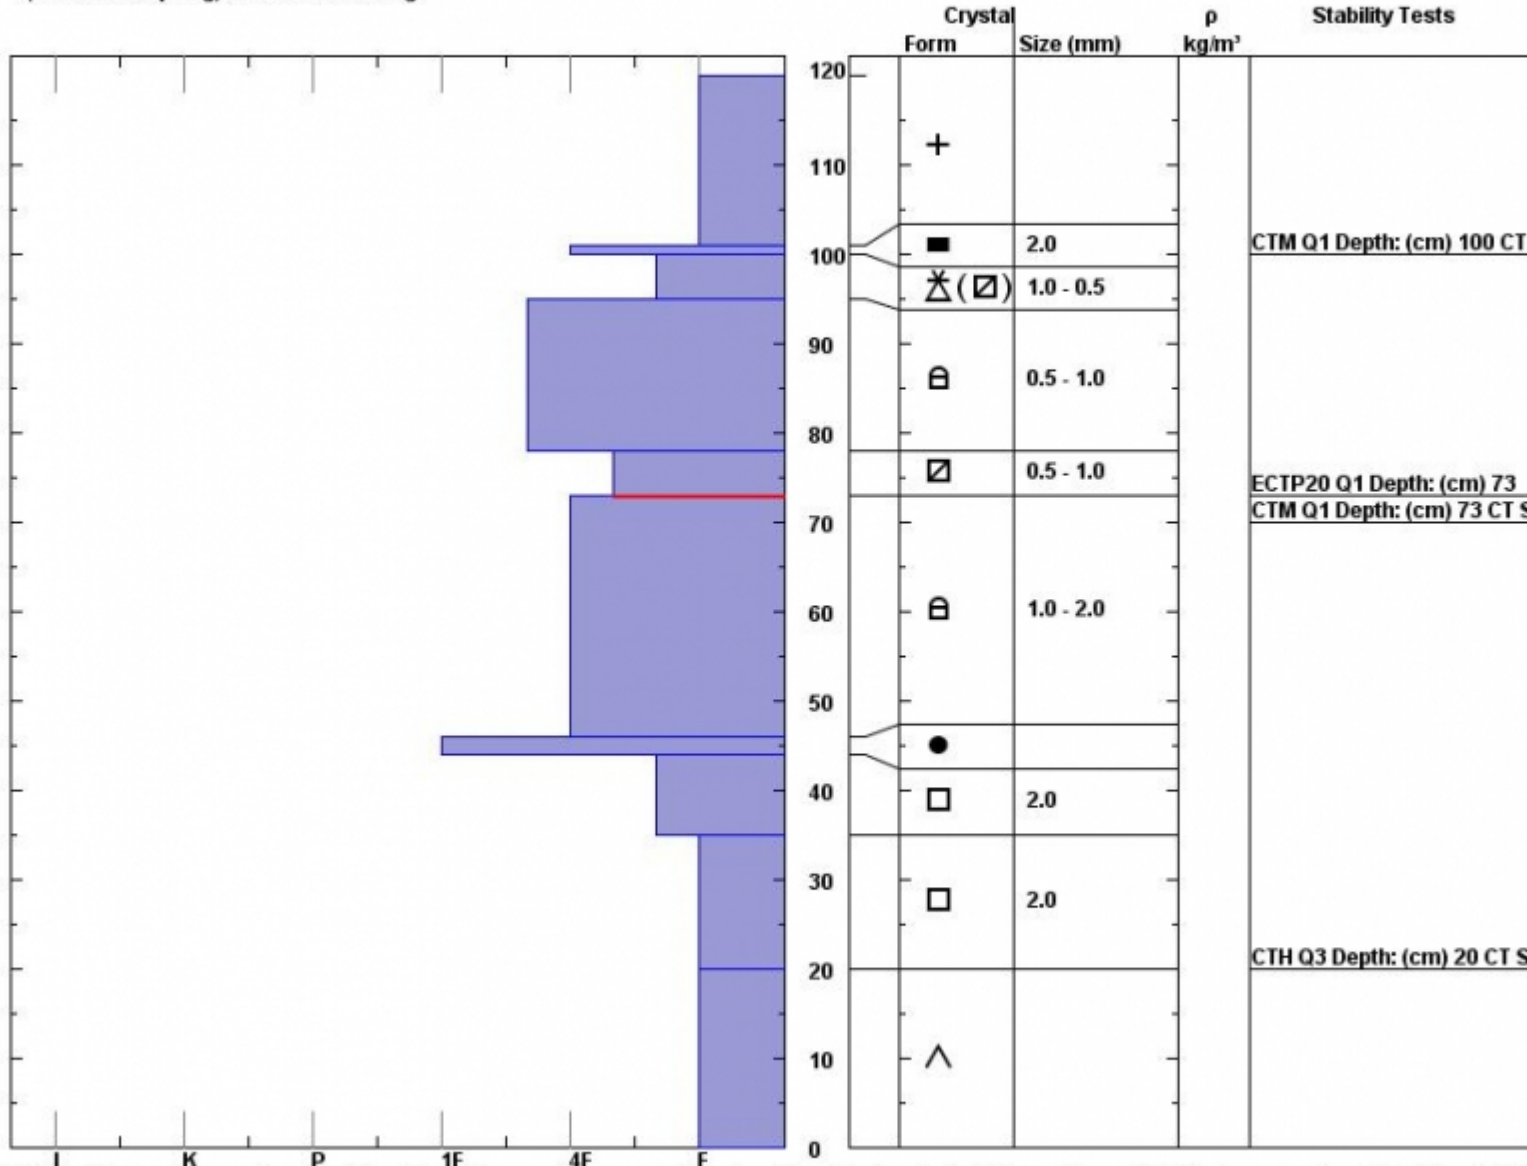
Stability Test Notes: Layer note  
**73-78: Pro**

Notes: Pit was dug near the ridgeline. We got large collapses and cracks at the ridge too, but not down below. Stability is suspect and I don't trust it. I skied the lower angled trees to the lake.
